ACCESS AUDIT REPORT

LYNDHURST JUNIOR SCHOOL A King's Group Academy

Lyndhurst Junior School - A King's Group Academy

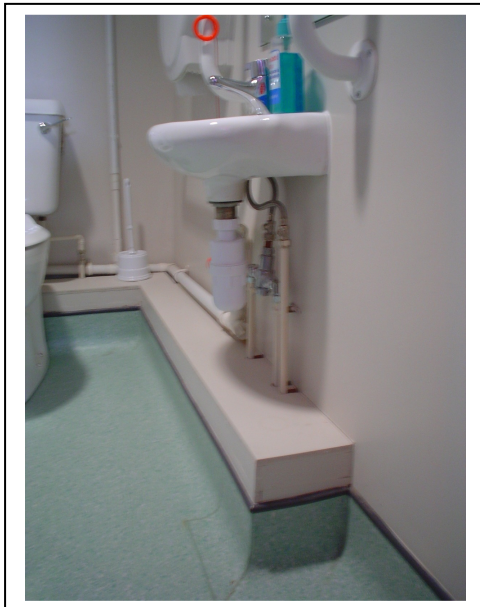
The boxing beneath the hand basin obstructs wheelchair user's wheels from positioning in front of the basin.

Hand basins should be cantilevered and free from any pipework boxing underneath.

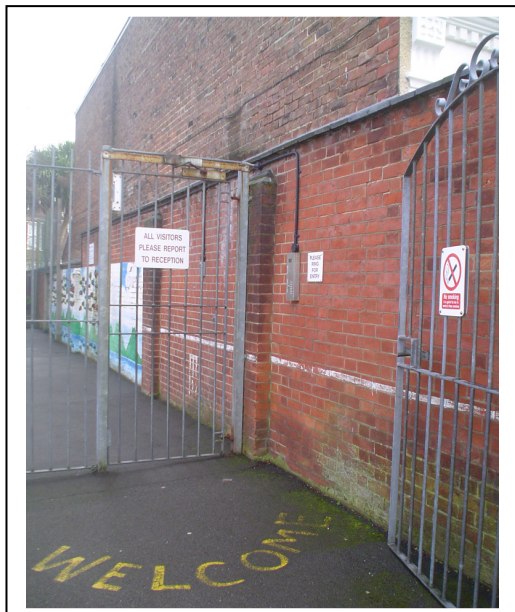
Location	Problem	Recommendation
Gate access control unit.	<p>The door control on the gate is slightly too high for wheelchair users. It is also an audible system, therefore not accessible to deafened people.</p> <p>Effect Analysis</p> <p>This may make it difficult for deaf people with hearing aids to understand the spoken instruction.</p> <p>Impact 1-5</p>	<p>Consider how this can be improved. Firstly, it needs to be lowered to a height between 750 mm and 1100mm above ground floor.</p> <p>Secondly, consider possibly installing a LED indicator to prompt caller to open door when invited to do so.</p>
External lighting	<p>There is sufficient lighting along the pathways towards the main entrance door.</p> <p>Effect Analysis</p> <p>People with disabilities, in particular visually impaired people are very vulnerable if lighting is poor.</p> <p>They are also prone to falls if they cannot see clearly.</p> <p>Impact - Excellent</p>	<p>Apart from maintenance there is no further works are required for this item.</p>

The door control on the gate is slightly too high for wheelchair users. It is also an audible system, therefore not accessible to deafened people.

It needs to be lowered to a height between 750 mm and 1100mm above ground floor.

Consider possibly installing a LED indicator to prompt caller to open door when invited to do so.

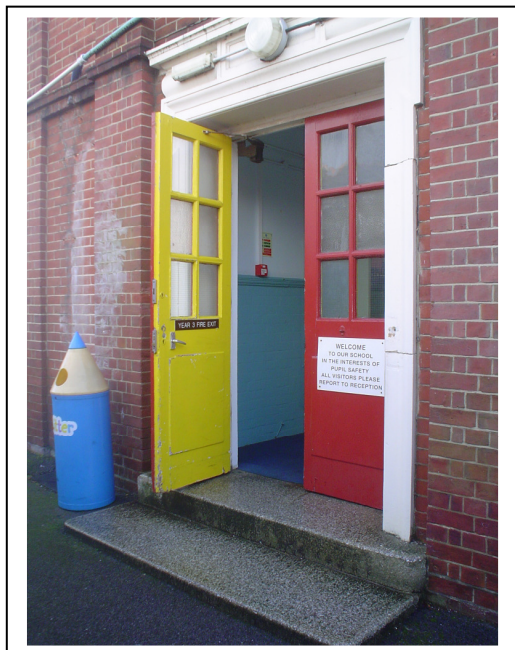
External steps to all areas- North Door Year 3 Steps

Location	Problem	Recommendation
	<p>It also does not have the corduroy tactile warning surface to forward blind people using white guidance canes that there are steps present.</p> <p>There are handrails to both sides. However, the widths of the handrails are not in accordance with document M of the Building Regulations. They do not serve as a useful grip for those that need to hold onto the railing.</p> <p>The do not extend 300 mm beyond the bottom step.</p> <p>Effect Analysis</p> <p>Small pupils with disabilities or those with vision impairments may feel very vulnerable using these steps.</p> <p>Impact 1- 5</p>	<p>Provide 'warm to touch' polyester powder coated handrails for both sides to Document M (2015) of the Building Regulations.</p> <p>Provide tonal/colour contrast to step nosing to assist visually impaired visitors.</p> <p>Portacabin Steps</p> <p>Provide additional 'warm to touch' polyester powder coated handrails for both sides to Document M (2015) of the Building Regulations. This should be positioned to enable smaller people use them.</p> <p>Provide tonal/colour contrast to step nosing to assist visually impaired visitors.</p> <p>If it is safe and appropriate to do so, provide 'corduroy' tactile warning surfaces to the top and bottom approach to the steps.</p> <p>Check that the building management is geared up for Fire Escape standard under Document B Fire Safety Building Regulations for means of escape for disabled people.</p>

It does not have any handrails or highlight colour band for the nosings.

It does not have the corduroy tactile warning surface to forward blind people using white guidance canes that there are steps present.

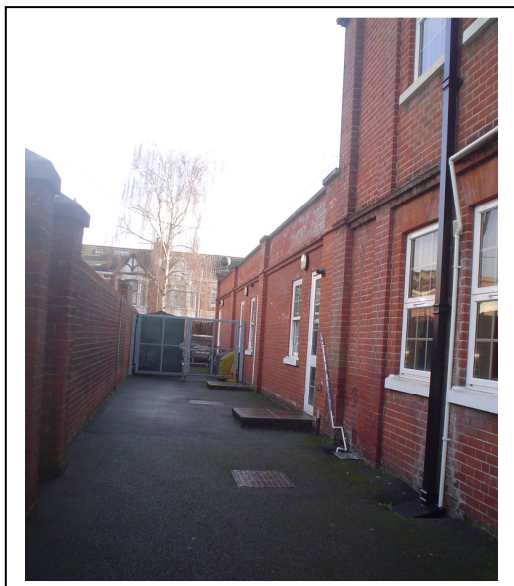
External Access Steps from Fire Exits and Corridors

Some exit doors leading to outside areas have one stepped platform.

There is no step nosing highlight colour band to warn of these stepped platform. In wet weather and dull lighting conditions, these are not clearly visible.

The dimension between ground level to step is minor – it is suggested to raise ground level so that it is flush with door thresholds.

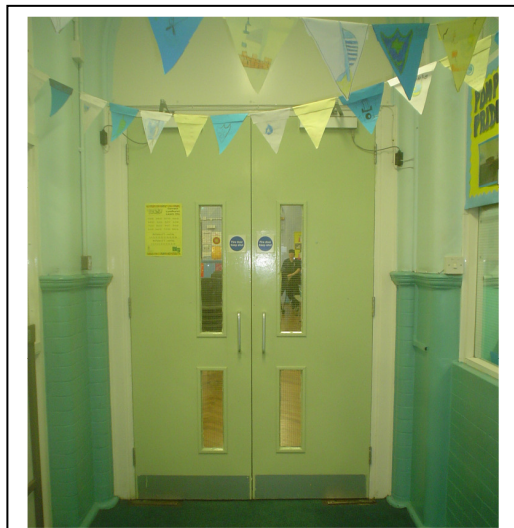
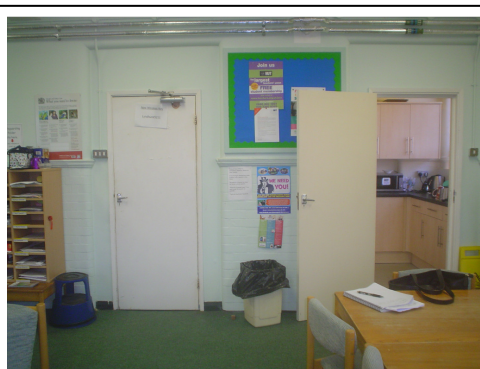
Internal Doors- Classroom and other doors

Location	Problem	Recommendation
	<p>the lobby doors (North doors). Being a wide door, there is concern for passing persons in this corridor.</p> <p>The staff room door opens inwards. It is a very narrow door of 710 mm clearance and has no vision panel. During the audit survey, it was noticed that staff came in quite quickly.</p> <p>The Hall doors (Fire door) leading from the corridor are also extremely heavy to manage.</p> <p>The corridor doors e.g. adjacent to room 6PH have narrow panels measuring 680 mm each. Other corridor doors are sticking and not closing securely.</p> <p>Effect Analysis</p> <p>People could collide with the classroom door if there is someone passing by on the corridor.</p> <p>The staffroom door may be an issue for the staff member with a disability in that if close to an opening door, he/she may not be able to move out of the way quickly to avoid collision.</p> <p>Wheelchair users and those using walking aids will find it extremely difficult to open the narrow corridor doors independently. This is because the need to open both doors to get through.</p> <p>Outward opening doors into a busy corridor is a potential hazard under Document M (2) of the Building Regulations.</p> <p>Impact –1-5</p>	<p>Consider replacing the corridor double doors with a wide single leaf door of 750mm minimum (800mm preferred) and a smaller door panel. Ensure that they close securely and open with ease.</p> <p>It may be possible to rearrange the classroom door (<i>and others if appropriate</i>) to open into the room. This would eradicate the potential hazard for disabled people passing.</p> <p>If possible, widen the Staff room door to at least 750mm minimum (800mm preferred). Replace the door with Document M specification door with vision panels. If privacy is an issue, the glassed panel can be a frosted style but it will still highlight an approaching person behind the door.</p> <p>To all doors, check and slacken off the opening /closing forces wherever necessary.</p> <p>See door opening forces guide under 'Other considerations'.</p>

The staff room door opens inwards. It is a very narrow door of 710 mm clearance and has no vision panel.

The corridor doors e.g. adjacent to room 6PH have narrow panels measuring 680 mm each. Other corridor doors are sticking and not closing securely. Consider replacing the corridor double doors with a wide single leaf door of 750mm minimum (800mm preferred) and a smaller door panel.

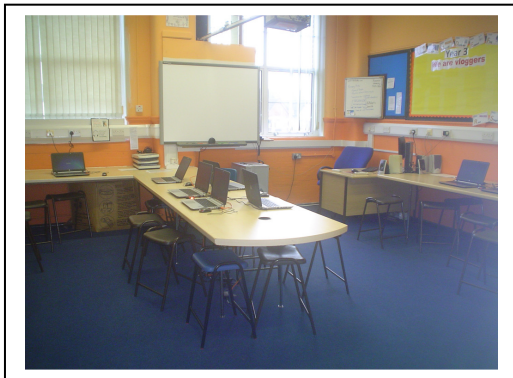
I T Computer areas

On the upper level, near the library, there is a computer training suite.

Sixteen laptops are situated around the worktops. The seating are tall stools but no adjustable seating. These stools are quite high and do not have armrests.
